Installation of boiler flues and ventilation perforations in external timber framed walls and other such structures.**Purpose.**

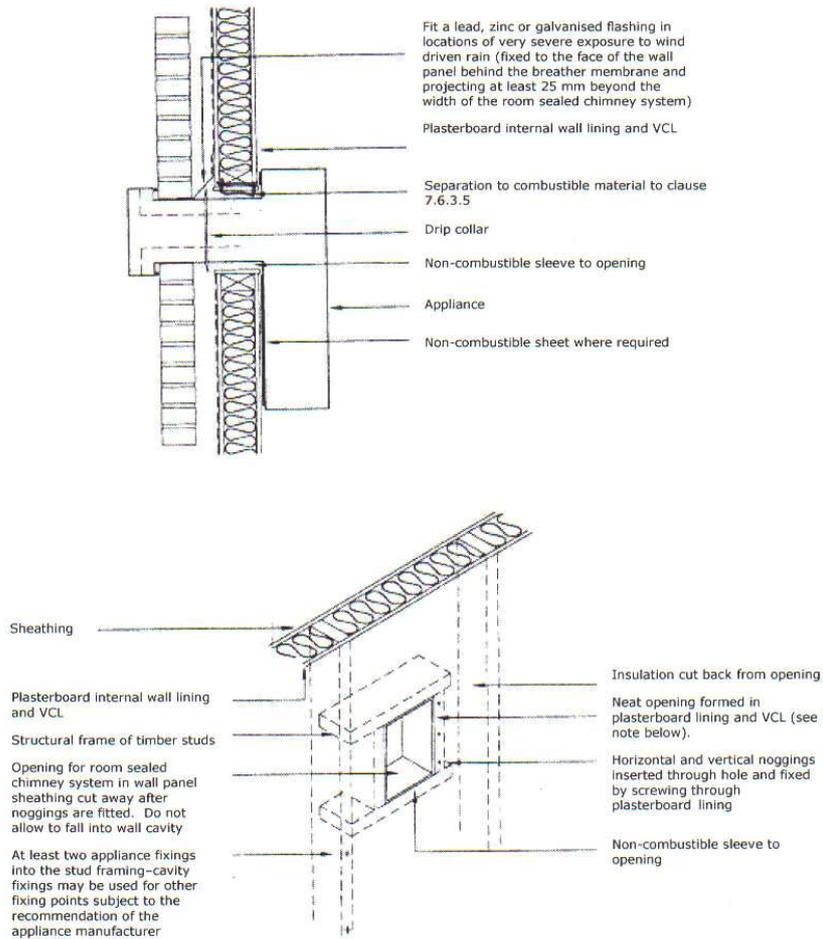
FIGURE 6 - FITTING A WALL MOUNTED ROOM SEALED APPLIANCE ON AN EXISTING TIMBER FRAME EXTERNAL WALL

The detail, some times referred to as the “Biscuit Box” for obvious reasons should be constructed of non combustible materials i.e. fire resisting boarding cut to size with the vapour and breather membranes affixed to the lips of the box. The void between the boiler or ventilation flue should be packed with non combustible wool material and a cavity tray affixed above to ensure no water ingress. The packing etc. is not indicated on the detail. However this is to ensure that the minimum thermal requirements of part C 0.7 w/m² can be achieved.

Note: Fit circular sleeve for appliance with circular flues. For further details, see Figures 7-11.

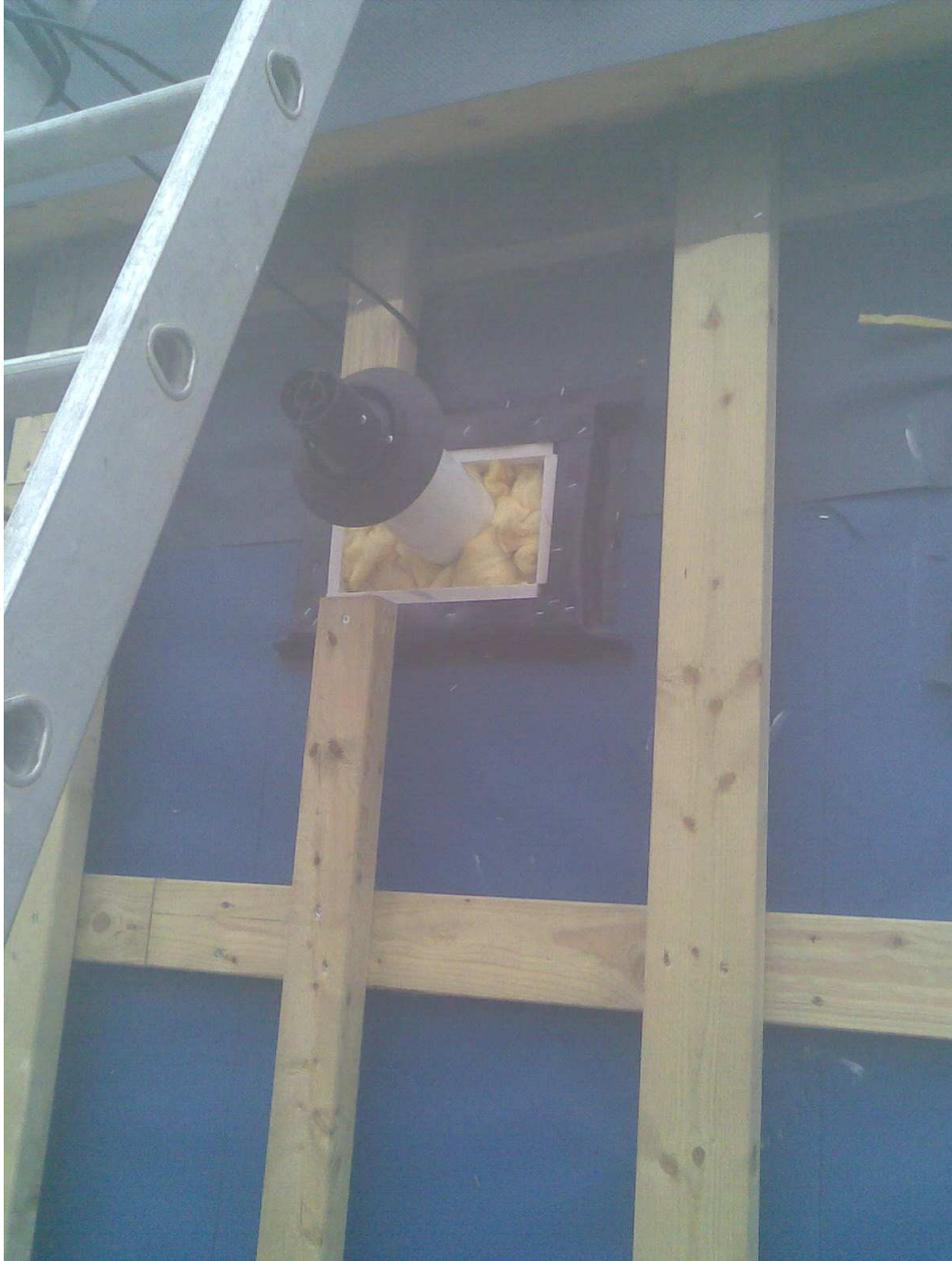
Note: ~ the picture has been taken before the drip plate, preformed membrane cover and the external insulated sheeting has been applied. This is to show the correct lapping of the breather membrane around the "Biscuit Box" construction comprised of fire resisting board material (in this case fire line). Due to the requirement of the flue distances to the timber noggins, to which the fire board is affixed, the void within the box is quite large and required insulating with Rockwool to achieve / exceed the minimum insulation values required in Part C. (Note at the time this picture were taken the incorrect insulation had been affixed)

It is interesting to note the insulation issue, as even when an experienced site installer tries to ensure that the constructional provisions are correct, the site laborers, who were requested to install the insulation within the boxes, used the wrong material due to an on site misunderstanding.
